A systematic approach to reduce operational cost for a medium-sized RO.

CASE STUDY OF A DRINKING WATER BOTTLING FACILITY

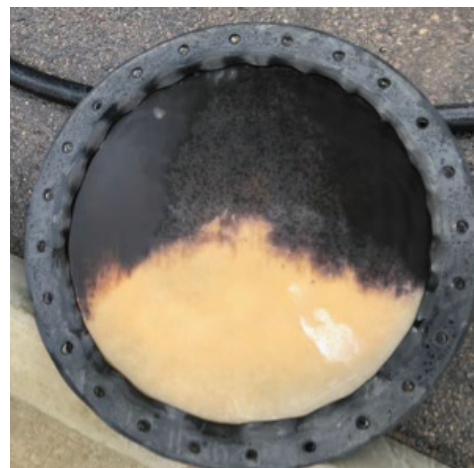
FIGURE 2. MANWAY DOOR

This finding prompted the operators to inspect the holding tank. Black sludge streamed from the tank doorway once opened. Photos of the inside of the tank were taken revealing the walls and the floor of the tank were heavily coated with a layer of manganese. An emergency tank cleaning was scheduled for next day. The tanks were cleaned with a specialty cleaner designed to remove metals. Figure 2 depicts the manway door after being partially cleaned.

It was later discovered that the tanks had not been inspected or cleaned since the startup of the system 10 years ago. The site believed that the manganese in the tank was likely a result of small bypasses throughout the years accumulating, which then sloughed off the tank periodically, fouling the cartridge filters and RO. This would explain the variable lifespan of the CFs.

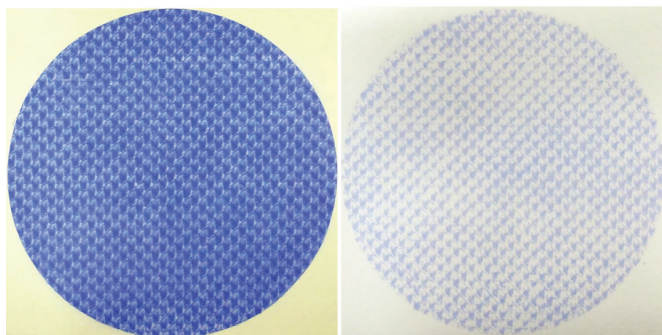
FIGURE 3. IMAGE OF THE DYE UPTAKE ON THE MEMBRANE SURFACE (LEFT) AND DYE PENETRATION TO THE MEMBRANE BACKING (RIGHT)

Significant dye uptake was observed on the membrane surface. Inspection of the membrane backing revealed dye penetration in a pattern consistent with the feed spacer voids. The results of dye testing are indicative of chemical damage to the membrane surface. Since Fujiwara testing was negative for halogen oxidation, it was determined that the most probable cause of oxidation was non-halogen oxidation.

was negative and dye testing displayed a consistent pattern with the Stage 1, Lead element. A symptom of chemical damage is damage across the full system. The system design was again reviewed for membrane incompatible chemistries including strong oxidizers. This revealed carryover of KMnO_4 , a strong oxidizer, as the most likely cause for the damage to the membrane.

of maintenance procedures performed on the GS filters and realized that the KMnO_4 dose remained consistent regardless of how many of the GS filters were operational. At times, only one GS filter was running therefore KMnO_4 was overdosed, causing membrane damage.

The plant was able to change the dosing procedures of KMnO_4 to account for the number of filters online by installing a flow-paced injection pump. But to be on the safe side the plant management decided to opt in to adding a reducing agent to neutralize any residual oxidizer.

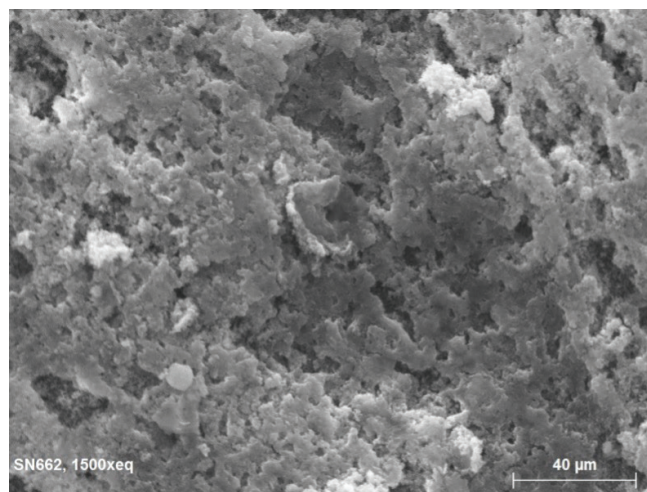
SEM imaging displayed a distinct botryoidal morphology which is commonly associated with silica scale and EDS confirmed silicon as the dominant inorganic element of the foulant (Figure 4).

FIGURE 4. SEM IMAGE AT 1500X (LEFT) AND EDS ANALYSIS AT 150X (RIGHT) OF THE MEMBRANE SURFACE

Elements	Membrane Surface (weight %)
Carbon	34.20
Oxygen	47.96
Sulfur	5.41
Silicon	12.43

Based on the foulant analysis it was determined that the foulant material on the membrane was primarily composed of silica scale. The autopsy results showed that the antiscalant used was not effective in inhibiting scale formation.

The autopsy results of the Stage 2 tail element identified the presence of silica scale. The antiscalant used at the plant prior to the audit was not a targeted formulation but a generic product used to disperse ions in solution. Based on the data collected from the full mineral analysis, it was apparent that using a specialized antiscalant that would target silica would offer better results. The new water analysis was entered into the chemical provider scaling prediction software to determine the maximum recovery in regard to the water chemistry. The software indicated the max recovery with the use of specialty antiscalant is approximately 82%. The software also showed that silica scale is the limiting factor. However, with current system design hydraulics limitations, the membrane design software indicated design warnings when exceeding the current recovery of 57%.
