A systematic approach to reduce operational cost for a medium-sized RO.

CASE STUDY OF A DRINKING WATER BOTTLING FACILITY

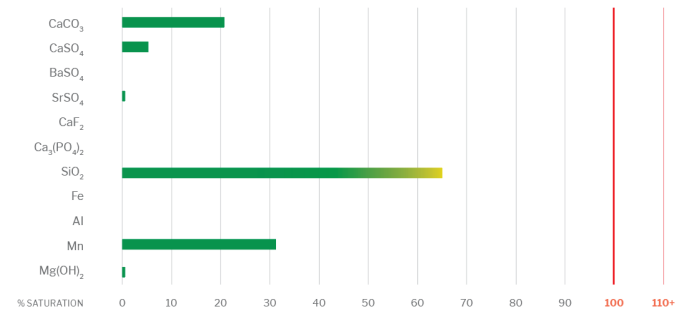
FIGURE 5. SATURATION INDICES AT 75% RECOVERY

(greater efficacy of a targeted product) and a decreased amount of feed water was being rejected into the concentrate stream. The saturation indices for the maximum recovery of 75% are provided below in Figure 5.
